Manhole Inspection Summary

Manhole # S27M__031MH

Insp Date: **5/13/08 9:22 AM**

Location Address: **838 Archer St**

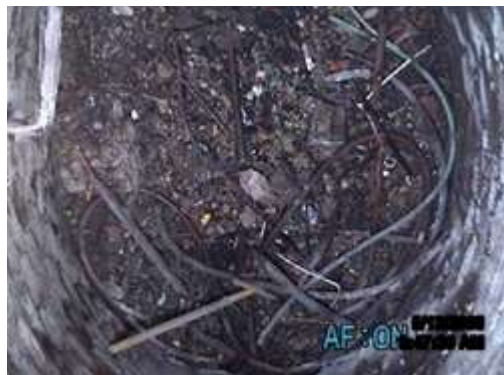
Defect 4

Condition: ☐ Sound ☐ Cracked ☐ Root Intrusion ☐ Deteriorated ☐ Leaks ☒ **Debris**

channel cond debris

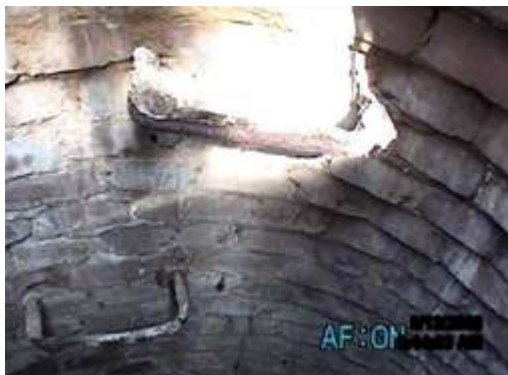
Defect 2

Count: **3** Missing: **0** ☒ **Corroded**

corroded steps

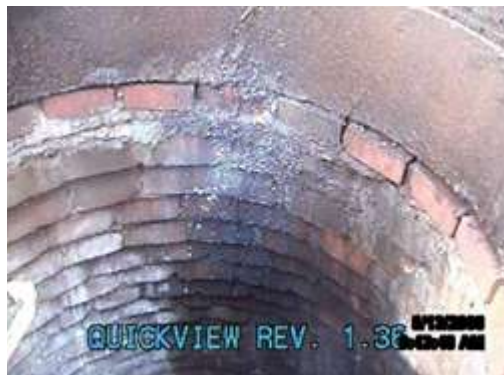
Defect 1

Condition: ☐ Sound ☐ Cracked ☐ Root Intrusion ☐ Loose Brick ☒ **Deteriorated**

Infiltration: ☐ None ☐ Joint ☐ Cracks ☒ **Mortar** ☐ Roots ☐ Wall

chimney mortar, chimney cond
deteriorated, chimney flow wall

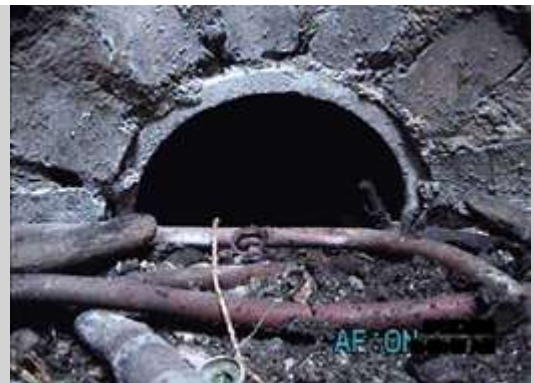
12 O'Clock Outflow

8 in. Circular Gravity Sewer
Pipe Out @ 12 O'Clock

Infiltration: **None** Pipe Seal Cond: **Sound**
